WL-TR-97-2053

THIN DENSE CHROME BEARING INSERTION  
PROGRAM

GE AIRCRAFT ENGINES  
ADVANCED ENGINEERING PROGRAMS DEPT  
ONE NEUMANN WAY  
CINCINNATI OH 45215-6301

FINAL REPORT FOR 03/01/92-12/01/96

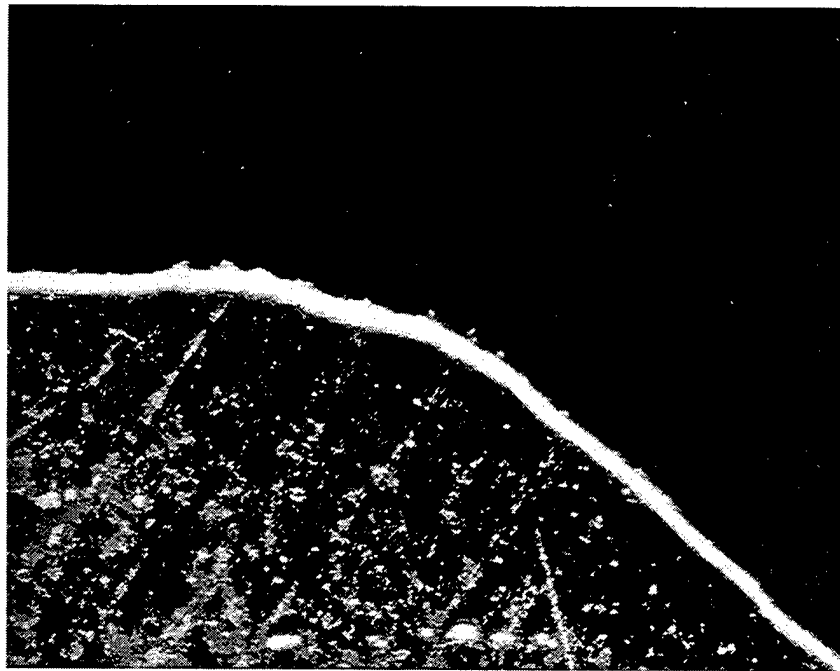
**Figure 85. Optical Photomicrograph of TDC Layer on Corner of Outer Ring, 220  $\mu$ m Thick.**  
*Met specification.*

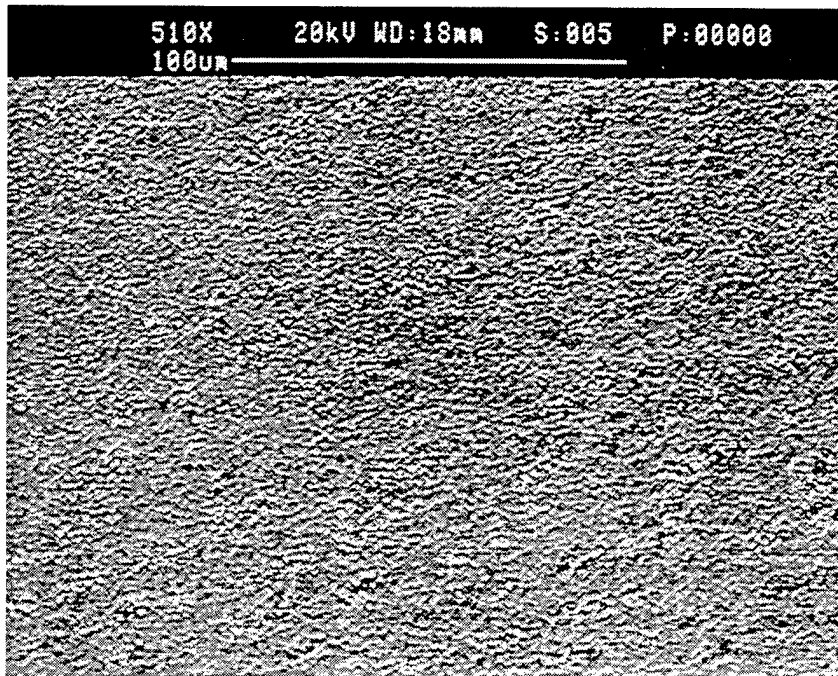
SEM examination of the bearing demonstrated that proper nodularity existed in the specimen. Figures 86 and 87 show the nodularity at magnifications of 500X and 1000X.

**Figure 86. SEM Photomicrograph of TDC Surface.** *Fine nodularity met specification.*

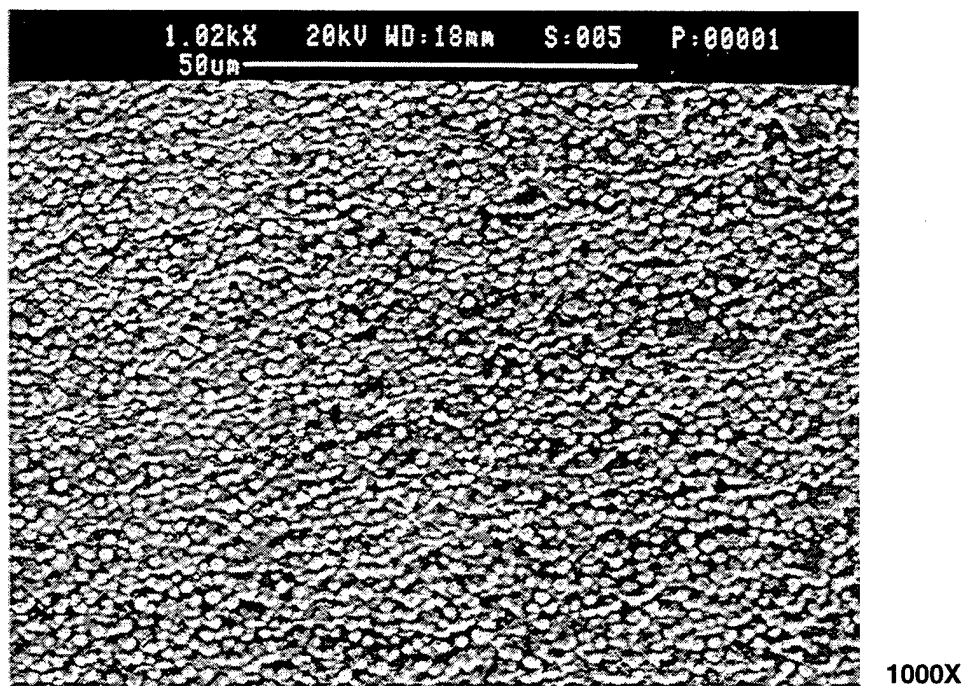
**Figure 87. SEM Photomicrograph of TDC Surface.** *Fine nodularity met specification.*

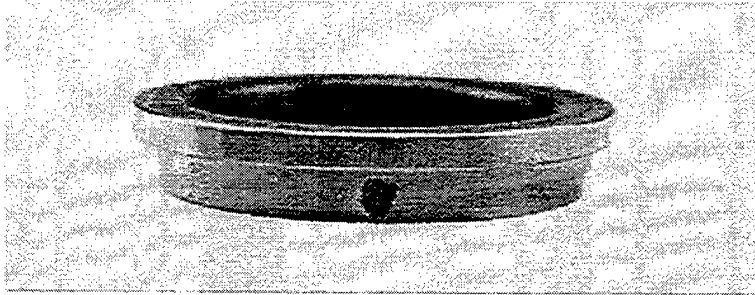
Two baseline (bare M50) failures occurred, one at 620 hours and the other at 4,030 hours. Five TDC coated bearings failed at 41, 225, 1,825, 2,293, and 2,710 hours. All failures were inner ring spalls. The estimated L10 calculation for the population based on this experiment was 2,943 hours for the baseline bearings and 519 hours for the TDC coated bearings. The TDC coated bearings L10 life clearly appeared inferior in RCF to the unplated baseline bearings. Figures 89 through 95 show both the failed baseline and TDC coated inner rings from this round of testing.

**Figure 89. Photo of Plain Bearing Spall Which Failed at 619 Hours.**  
*Only plain bearing to fail within 2,500 hours.*

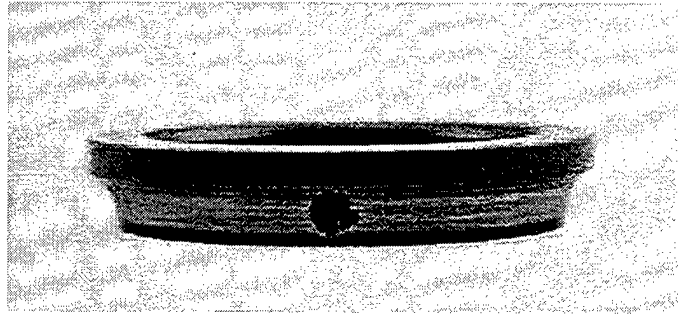
**Figure 91. Photo of TDC Coated Bearing Spall Which Failed at 41 Hours.**  
*One of five failures.*

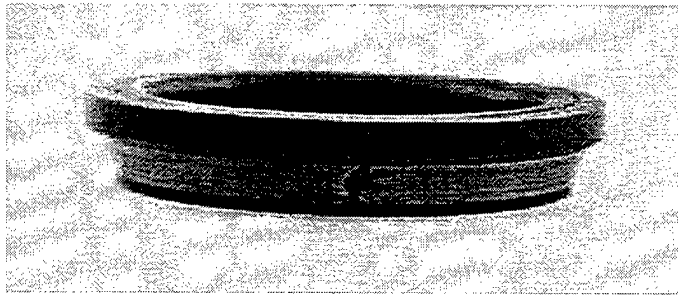
**Figure 92. Photo of TDC Coated Bearing Spall Which Failed at 1,825 Hours.**  
*One of five failures.*

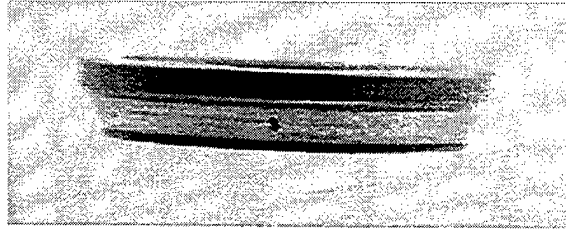
**Figure 93.** Photo of TDC Coated Bearing Spall Which Failed at 225 Hours.  
*One of five failures.*

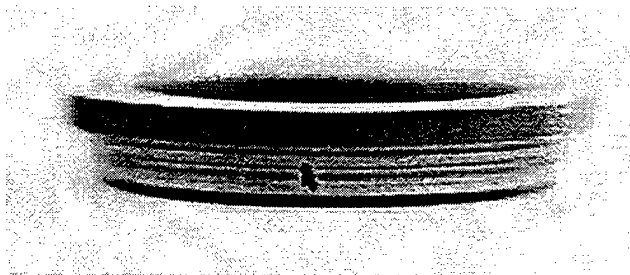
**Figure 94.** Photo of TDC Coated Bearing Spall Which Failed at 2,710 Hours.  
*Only TDC failure over 2,500 hours.*

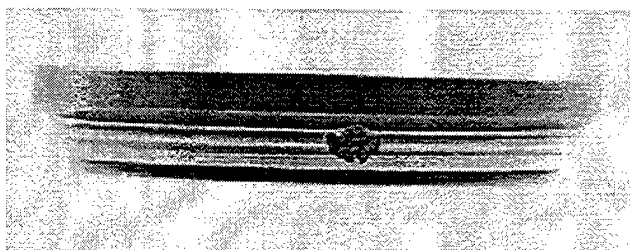
Surface roughness measurements of the inner race ball track indicated its preplate roughness was approximately  $2.0\text{ }\mu\text{in}$ , while its roughness postplating was on the order of  $4\text{--}5\text{ }\mu\text{in}$ . This corresponded to an initial Lambda around 1.2 to 1.8 for the plain bearings, and around 0.7 for the TDC coated bearing. As in the MRC bearings, this explains why the ball track in the plain bearings was so difficult to see, while they are

quite easily found in the TDC coated bearings. Again, it is generally accepted that the fatigue life difference between a bearing with a Lambda of less than 1.0 and one in which it is greater than 1.5 can be very substantial, since the low Lambda ratio bearing is much more prone to surface distress which can lead to early fatigue.

**Figure 95.** Photo of TDC Coated Bearing Spall Which Failed at 2,293 Hours.  
*One of five failures. Note easy to see ball track. The L10 of the TDC coated bearing was 1/6th that of the bare bearings.*

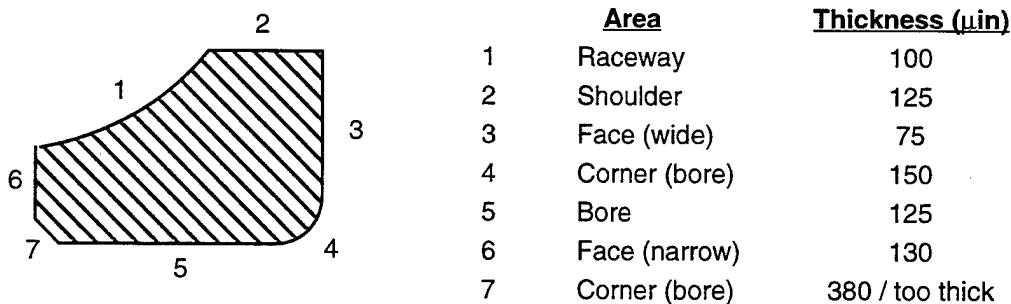
**Figures 96 through 104** show the TDC coatings of these seven areas. Note that area number seven, the bore corner, contained TDC with a thickness of 380 $\mu$ in, which is greater than the 250 $\mu$ in maximum allowed in the GE Specification. Examination of **Figure 104** also shows what appears to be microcracks running through the TDC coating. This condition is not evident in the thinner coating areas.

**Figure 96. TDC Plating Thickness Measurements.** Area 7 was the only measurement above the max. spec. thickness of 250  $\mu$ in.

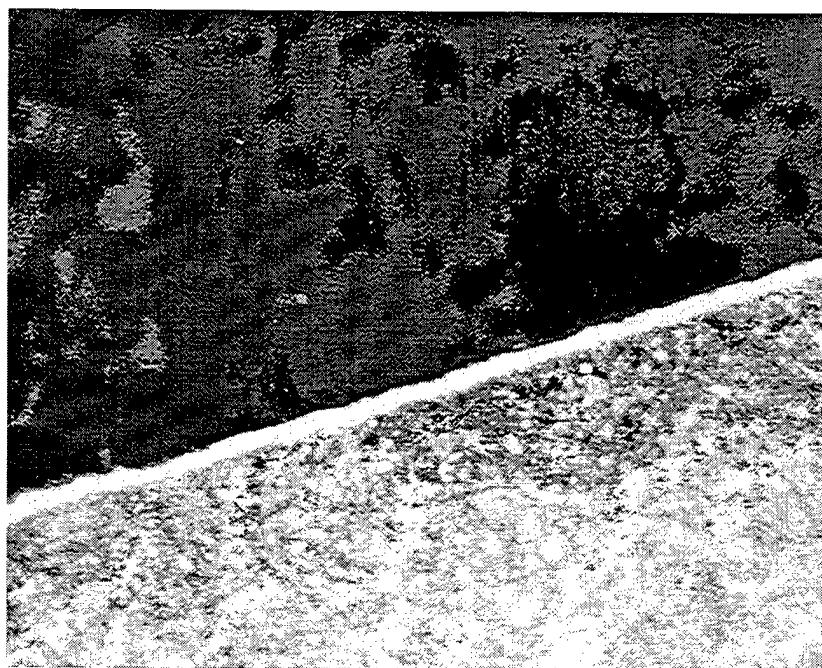
**Figure 97. Optical Photomicrograph of Raceway (Area 1) 100  $\mu$ in TDC Thickness.**  
*Within specification.*

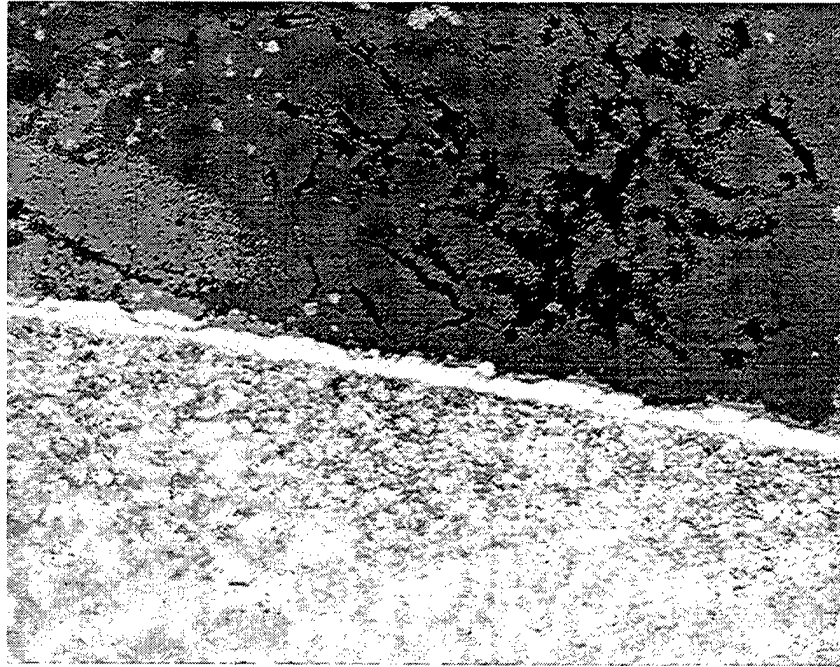
**Figure 98. Optical Photomicrograph of Shoulder (Area 2) 125  $\mu$ m TDC Thickness.**  
*Within specification.*

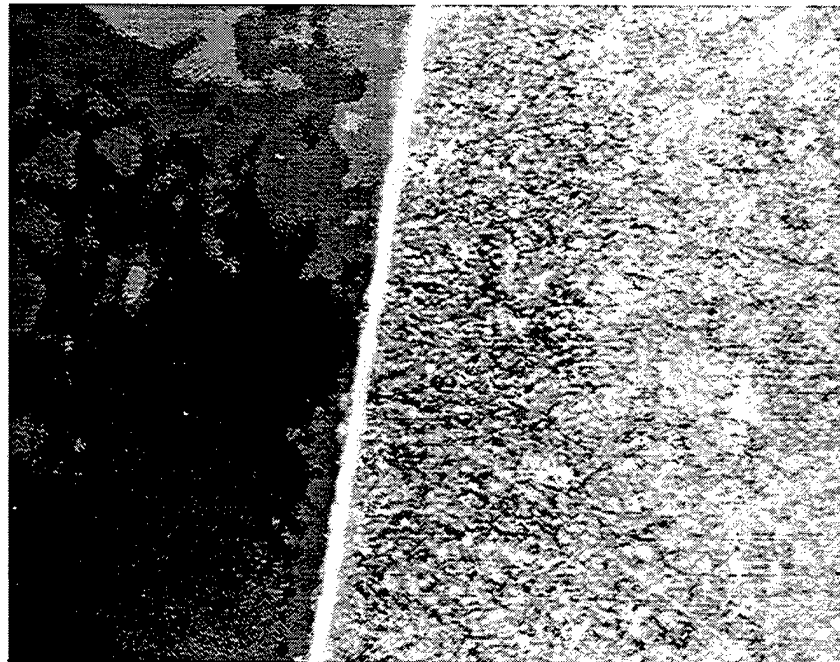
**Figure 99. Optical Photomicrograph of Wide Face (Area 3) 75  $\mu$ m TDC Thickness.**  
*Within specification.*

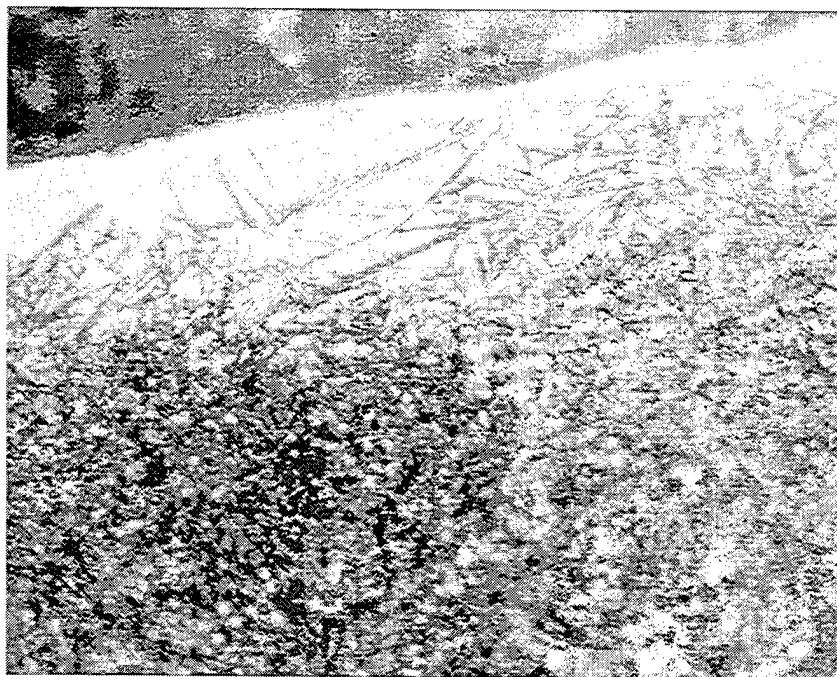
**Figure 100. Optical Photomicrograph of Bore Corner (Area 4) 150  $\mu$ in TDC Thickness.**  
*Within specification.*

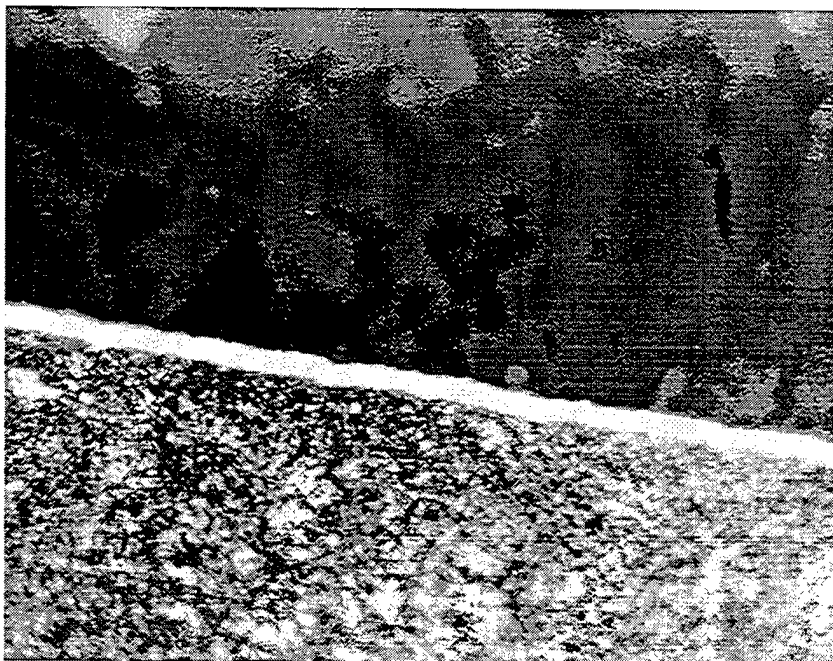
**Figure 101. Optical Photomicrograph of Bore (Area 5) 125  $\mu$ in TDC Thickness.**  
*Within specification.*

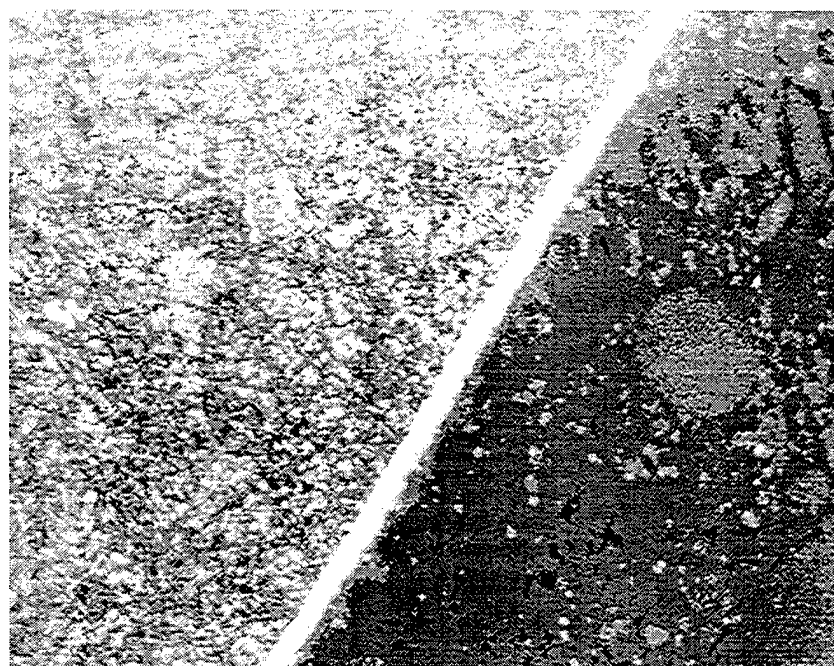
**Figure 102. Optical Photomicrograph of Narrow Face (Area 6) 130  $\mu$ in TDC Thickness.**  
*Within specification.*

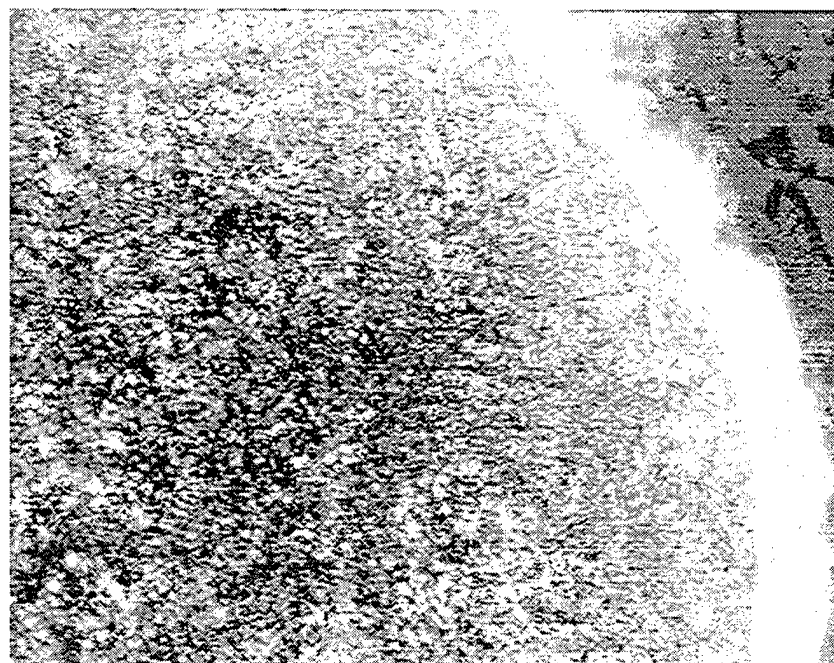
**Figure 103. Optical Photomicrograph of Bore Corner (Area 7) 380  $\mu$ in TDC Thickness.**  
*Above specification maximum of 250  $\mu$ in.*

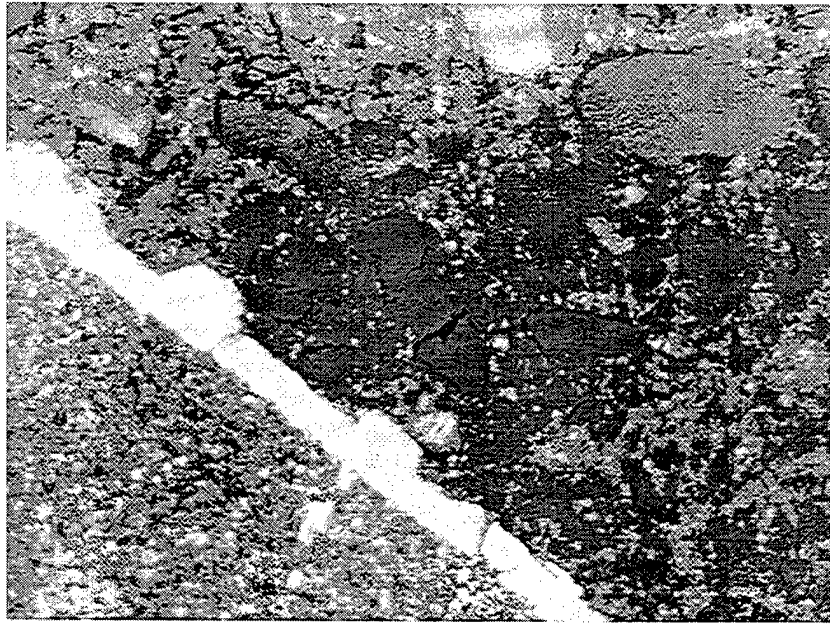
**Figure 104. Optical Photomicrograph of Bore Corner (Area 7) 380  $\mu$ in TDC Thickness.**  
*Above specification maximum of 250  $\mu$ in, note cracks in TDC plating.*

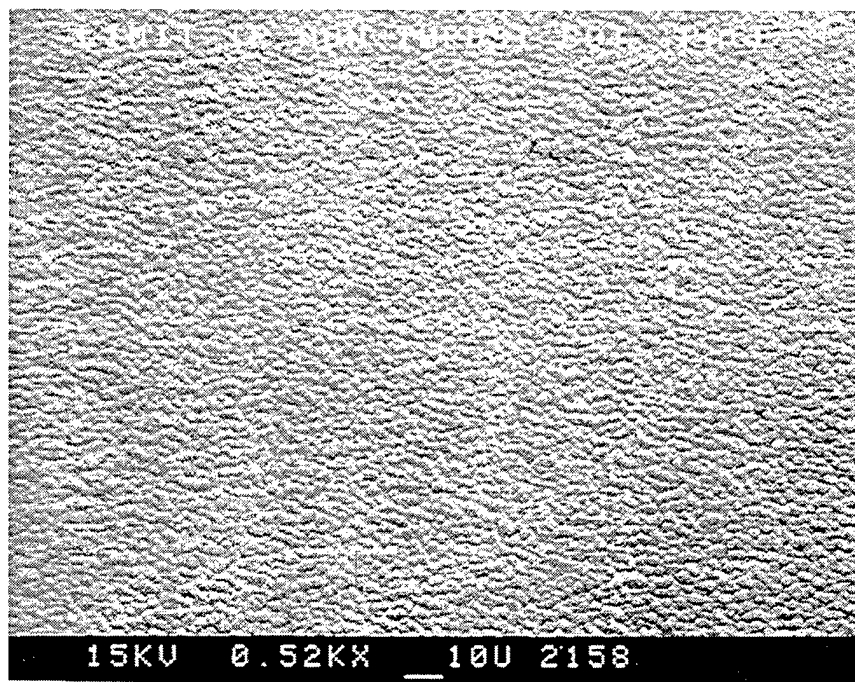
inspection at 500X revealed a proper looking nodular texture, as can be seen in **Figures 105 and 106.**

**Figure 105. SEM Photomicrograph of the Raceway Bottom Surface Texture.**  
*Within specification.*

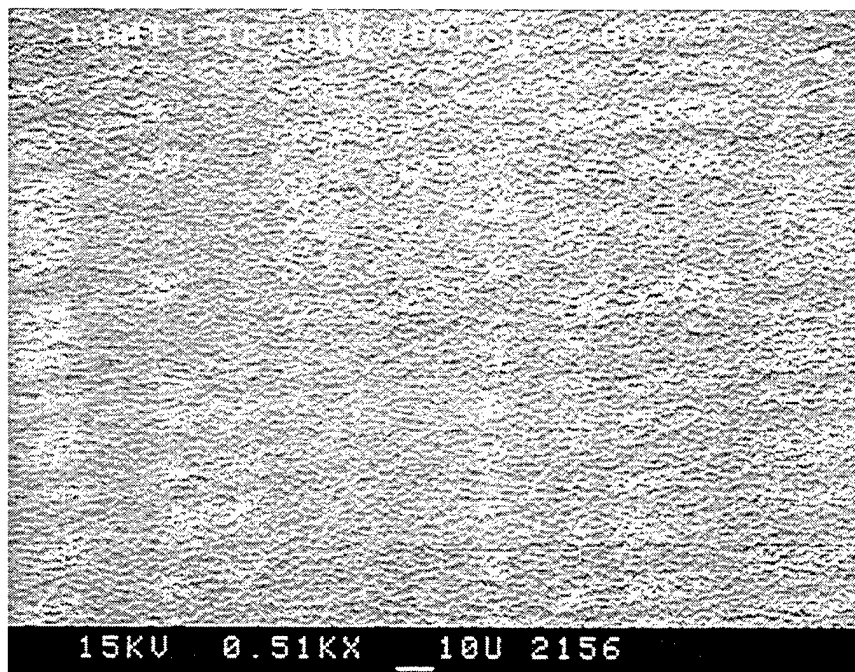
**Figure 106. SEM Photomicrograph of the Outside Diameter Surface Texture.**  
*Within specification.*

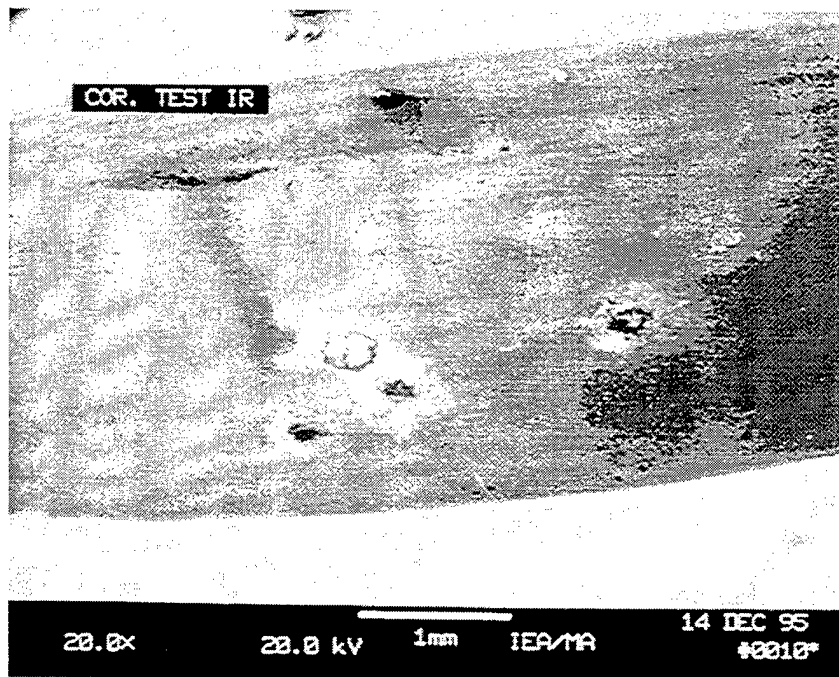
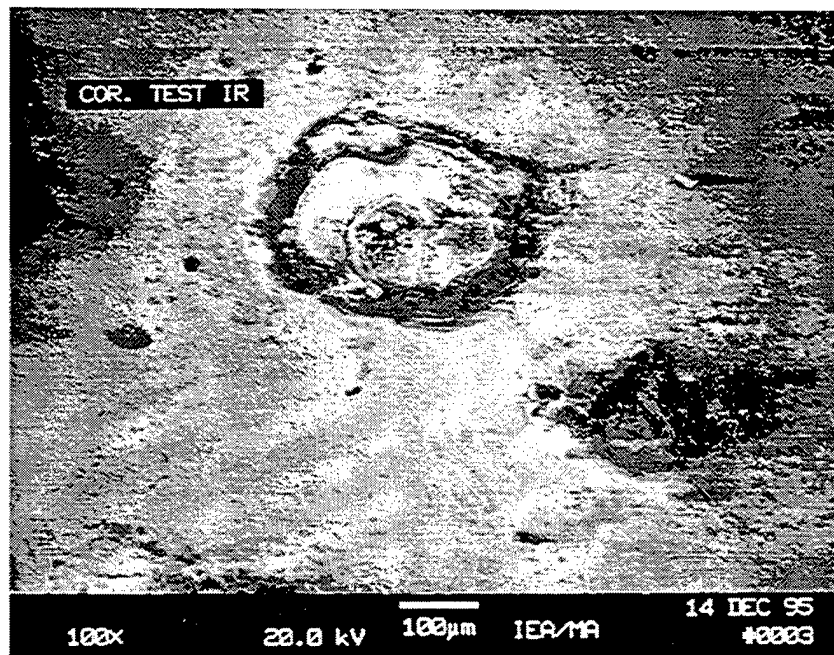
Corrosion testing was performed by Dirats Laboratories. The test ring exhibited isolated areas of rust spots after the 24-hour salt spray test. Additional testing was performed using an acidified copper sulfate to determine the presence of exposed iron. Areas of the bore to abutting face chamfer (Area 7 in Figure 96) and the shoulder exhibited a copper color after six minutes in the solution, indicating exposed iron. One of the corner areas adjacent to the corroded zone appeared to be delaminated. **Figure 107** shows the corrosion pits as a result of the salt spray test. Appendix D contains a certification report of this test.

**Figure 107. SEM Photomicrographs of Corrosion Test Pits on Bearing Shoulder.**  
*Failed test.*

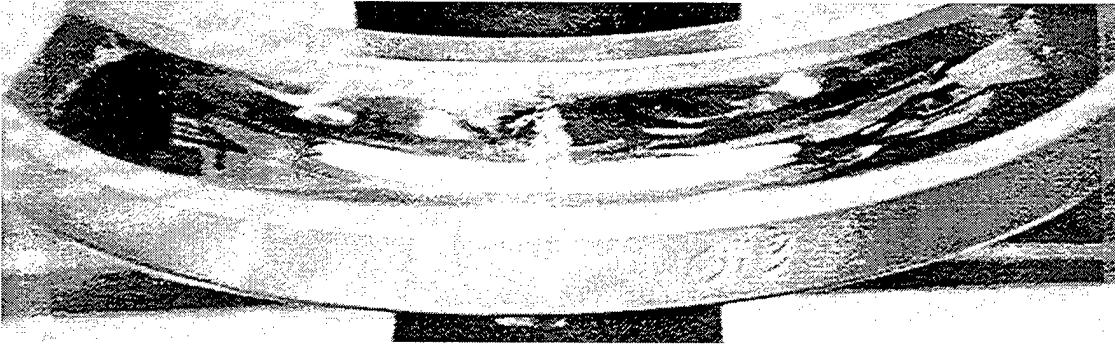
**Figures 108 through 112** show the spall failures in the baked TDC plated bearings. SEM examination of the failed bearings revealed that most, if not all, were again surface originated failures. Further examination on the SEM revealed areas just ahead of the spall origination point of distressed TDC, indicated by the white arrows in **Figures 113 through 115**.

**Figure 108. Photo of TDC Coated Bearing Spall Failure at 1002.7 Hours.**

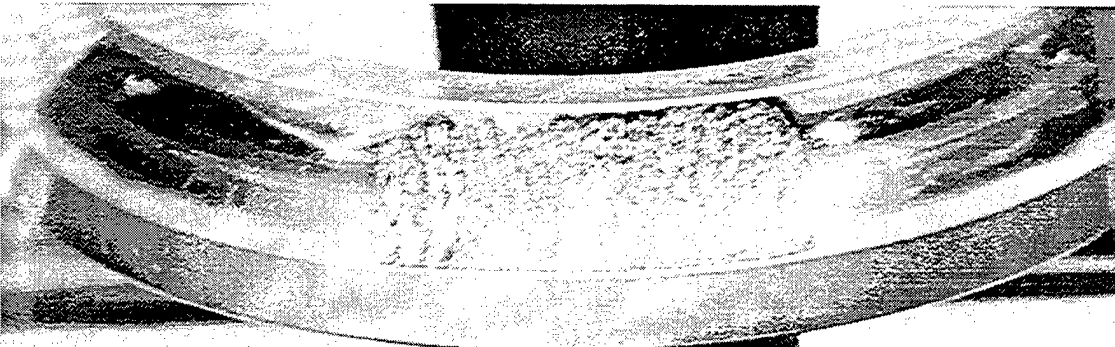
**Figure 109. Photo of TDC Coated Bearing Spall Failure at 1193.3 Hours.**

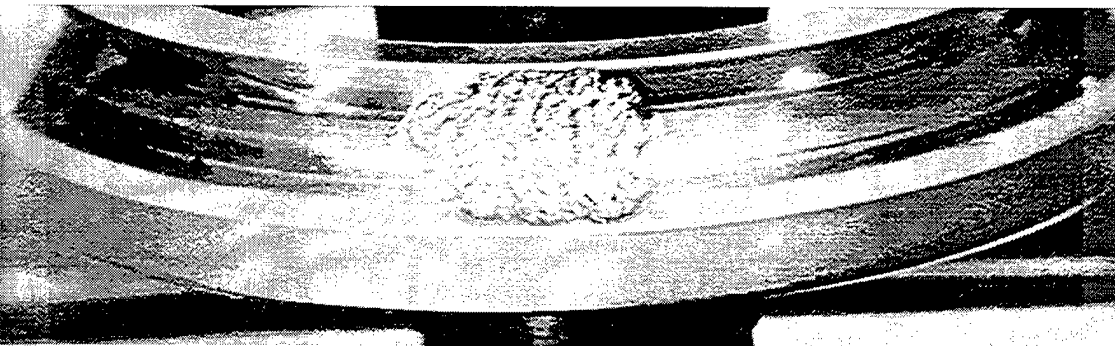
**Figure 110. Photo of TDC Coated Bearing Spall Failure at 246.6 Hours.**  
*Bearing had both large and small spalls.*

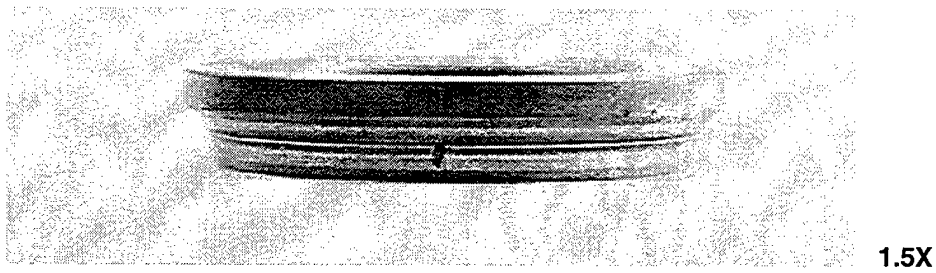
**Figure 111. Photo of TDC Coated Bearing Spall Failure at 500.8 Hours.**

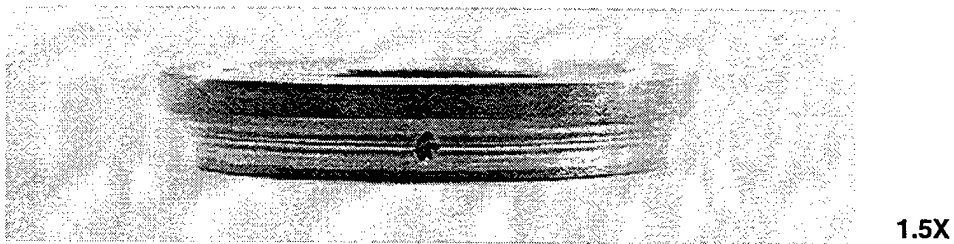
The contact ellipse of an angular contact bearing contains elements of rolling, sliding, spinning, and gyroscopic motion. It is the sliding, spinning, and gyroscopic motions which is suspected of causing the TDC distress and subsequent bearing failure, particularly if the Lambda ratio is low.

**Figure 112. Photo of TDC Coated Bearing Spall Failure at 710 Hours.**  
*The L10 of the TDC coated bearings was approximately 1/6th that of the plain bearings. A major concern exists in the application of TDC in low Lambda regions.*

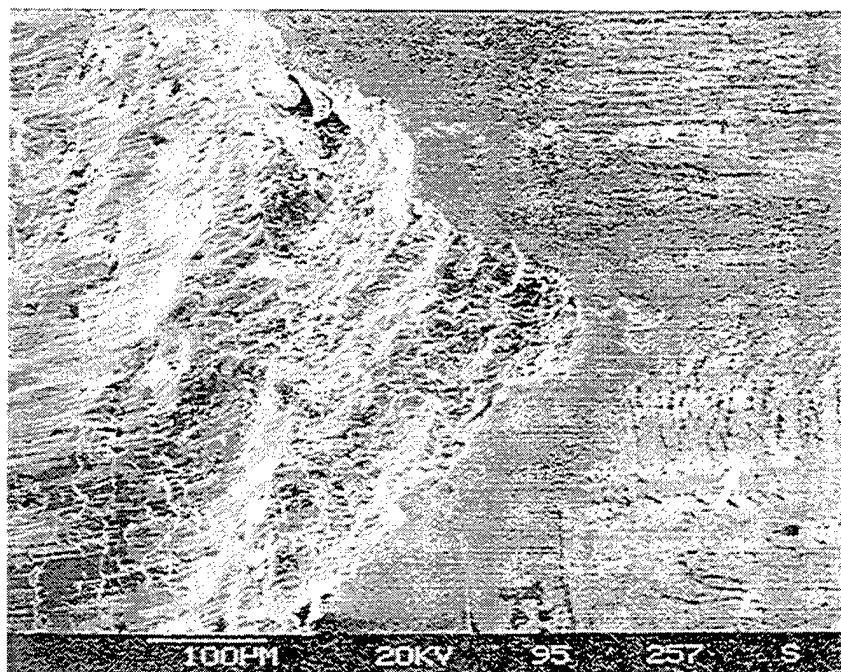
**Figure 115. Photomicrograph of S/N 0027 Inner Race Showing Distressed TDC Ahead of Point Surface Originated Spall.**

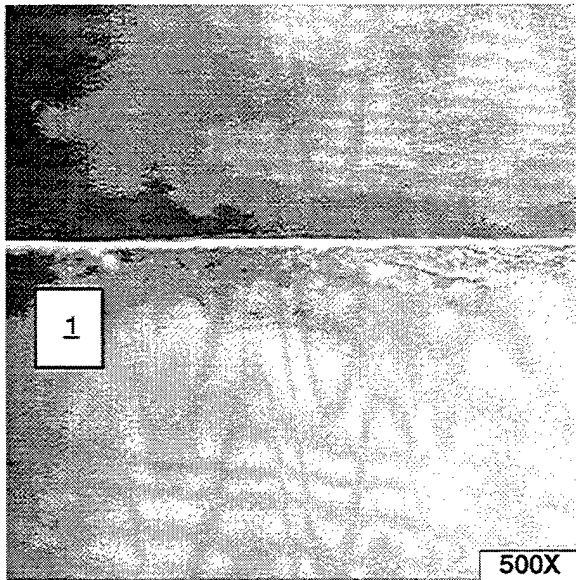
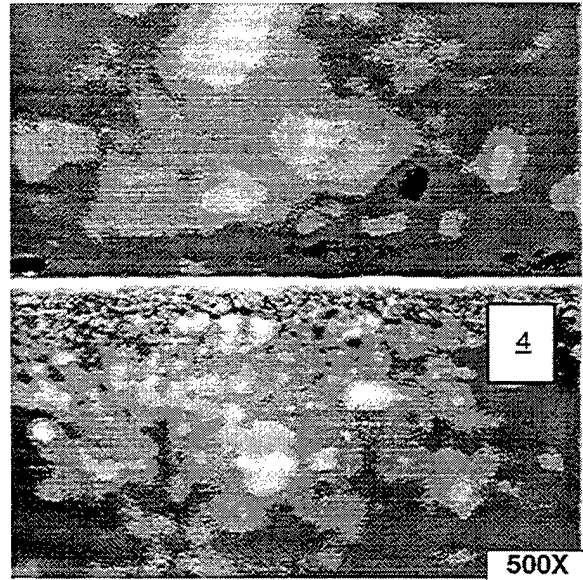
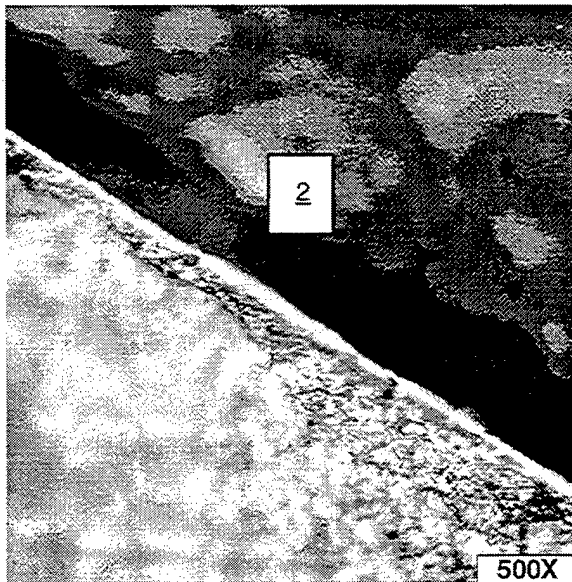
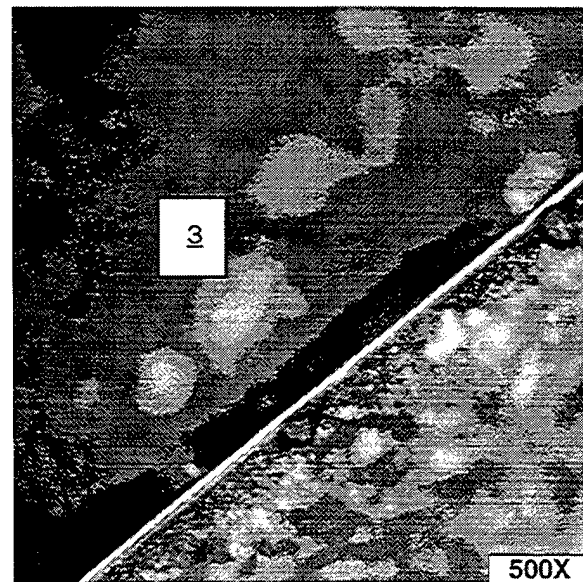
The second test was completed with two TDC coated M50 bearings. Both bearings successfully completed the required 1,000 hours of testing. Posttest inspection indicated that the TDC remained intact on both bearings. **Figure 119** illustrates the acceptable condition of the TDC coating after test.

**Figure 119. Photos of Contamination Tested TDC Bearing S/N MDACE705 After 1,000 Hours.**  
*TDC coating integrity demonstrated in contained environment.*

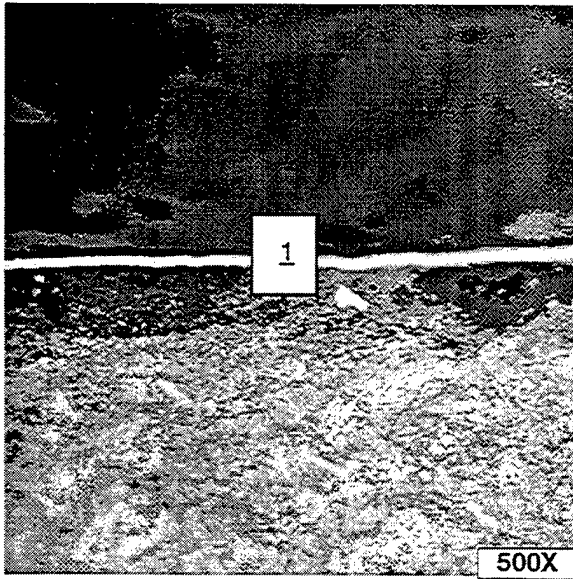
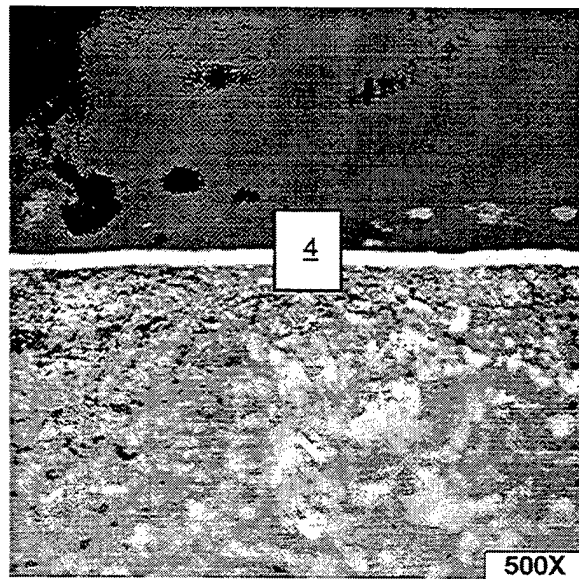
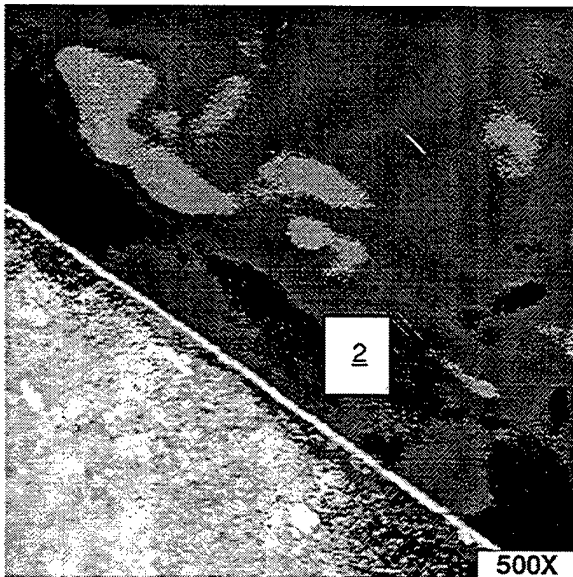
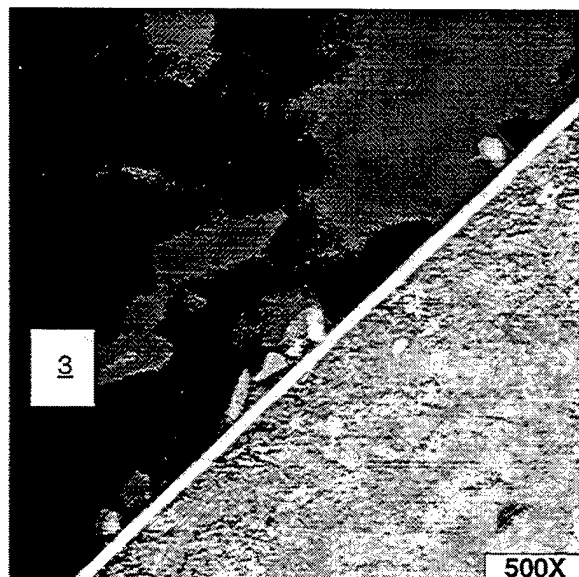
The TDC coating successfully adhered to the base material and did not demonstrate any evidence of distress resulting from oil-off testing. **Figure 121** is a photograph of a typical TDC coated bearing outer race after testing, illustrating the acceptable condition of the coating.

**Figure 121. Photos of Off-Oil Tested TDC Bearing S/N MDACE694.**  
*TDC coating demonstrated acceptable off-oil performance.*

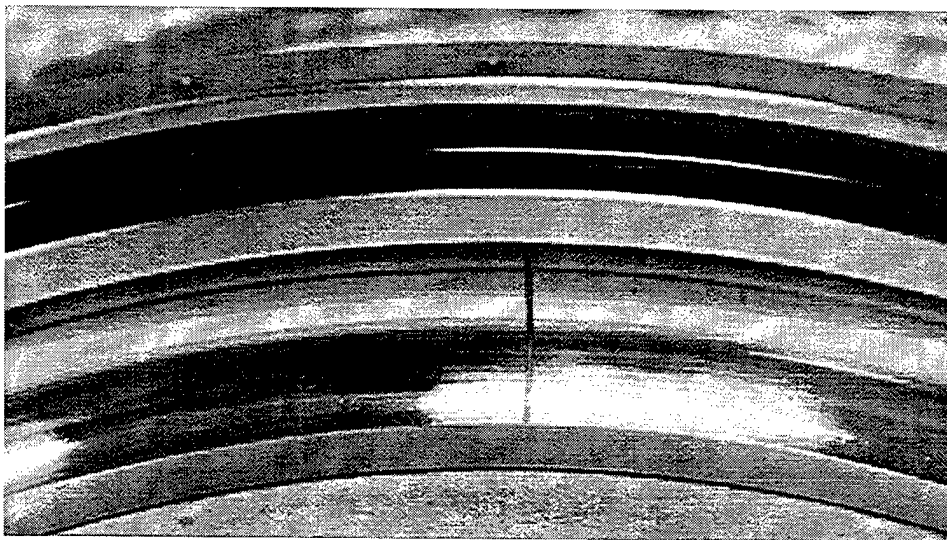
EDM Groove in Plain Outer Race  
P/N 9732M10P16  
S/N MDA605JV

A total of four bearings completed induced defect testing. Two TDC coated and two plain bearings were tested to compare the relative times from spall initiation to cage fracture. A 0.020 inch wide by 0.010 inch deep groove was machined across the entire raceway of each outer ring using an EDM process. **Figure 124** shows photographs of typical grooves in the raceways prior to test.

**Figure 124. Photos of EDM Groove Machined in Outer Race for Induced Defect Test.**

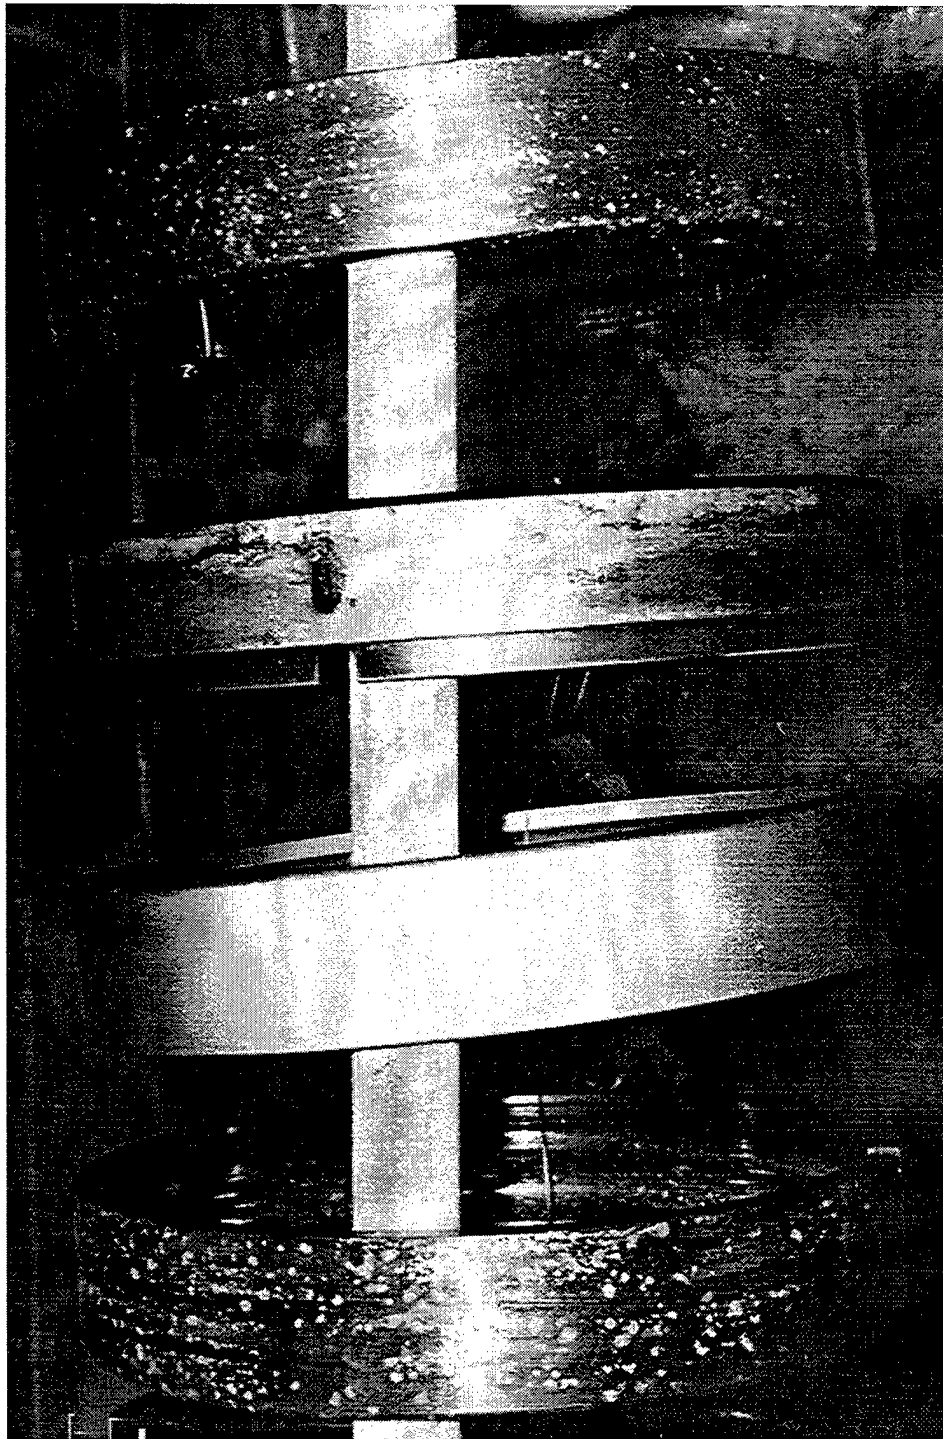
Figures 127 and 128 illustrate the conditions of the test races after atmospheric exposure. As evidenced by these photographs, the TDC coating provides a significant increase in corrosion resistance compared to plain bearings.

**Figure 128. Photos of Corrosion Resistance Test Bearings.**  
*TDC coating significantly improved corrosion resistance.*

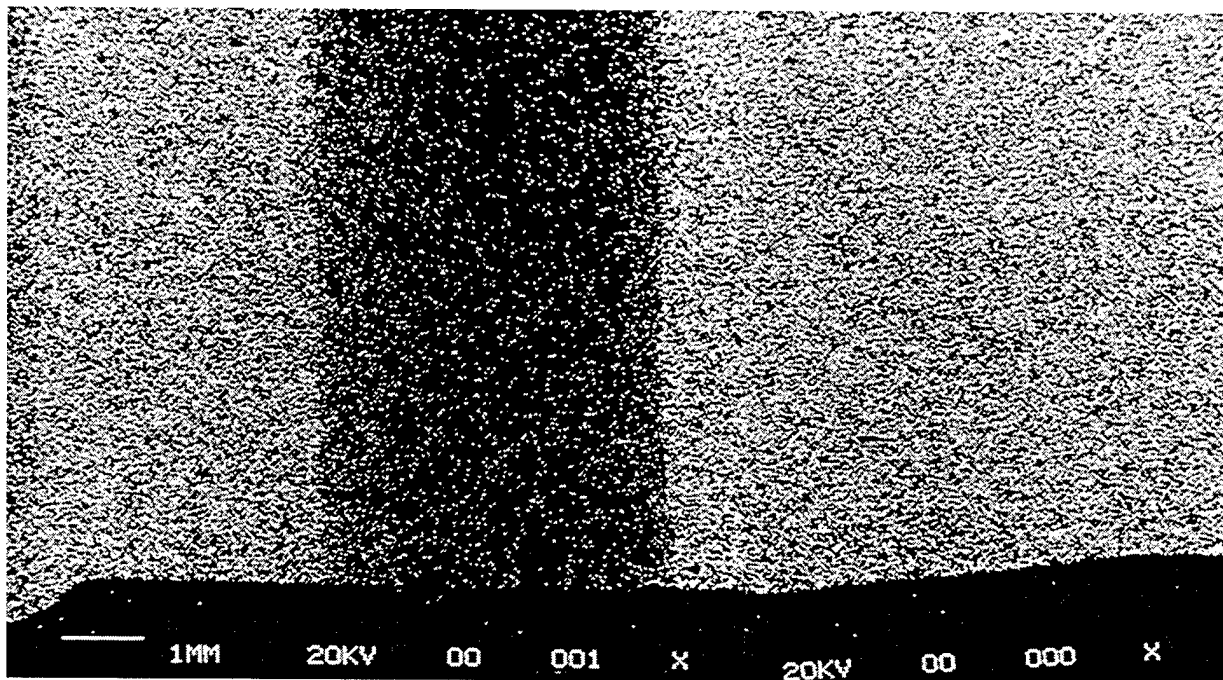
10X

The No. 3B bearing experienced skid damage which resulted in removal of the TDC in the skid affected area of the race and spalling of one ball. Figure 132 is an energy dispersive spectroscopy dot map of the raceway ball track

looking for chromium. TDC had been removed as indicted by the dark band in this photograph. Figure 133 is a SEM photograph of the spalled ball. Spalling originated at the surface, probably as a result of the skidding action which damaged the TDC coated race.

**Figure 132. Energy Dispersive Spectroscopy of F110-GE-129 ESN 538-103/4 No. 3 Bearing.**  
*Dark band in the center of the dot map indicated the TDC has peeled away. TDC coating is susceptible to operational skid damage.*

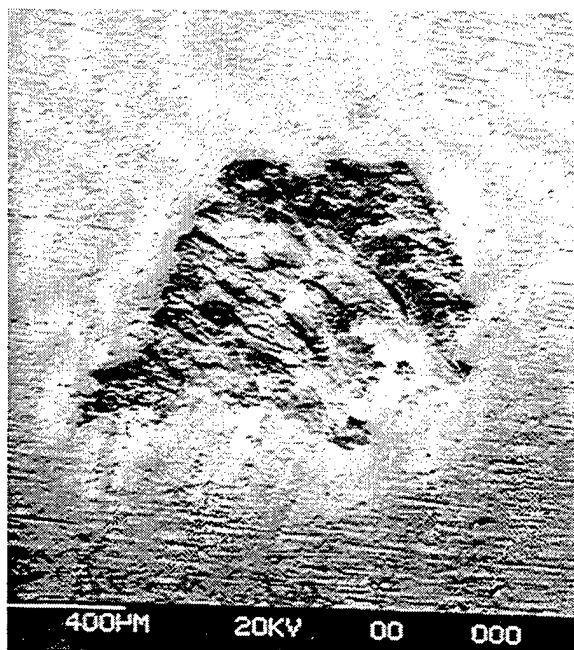
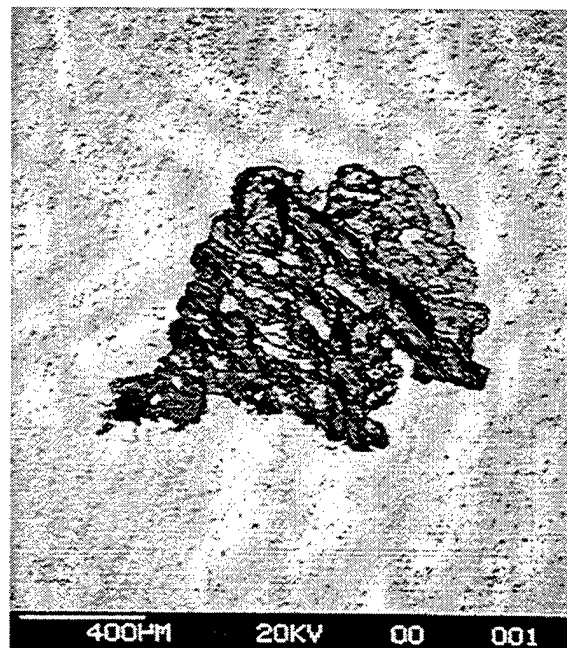
43X

**Figure 133. SEM Secondary and Backscatter Photos of Ball Spall.**  
*Skid damaged TDC coating initiated ball spalling in test of ESN 538-103/4 bearing.*

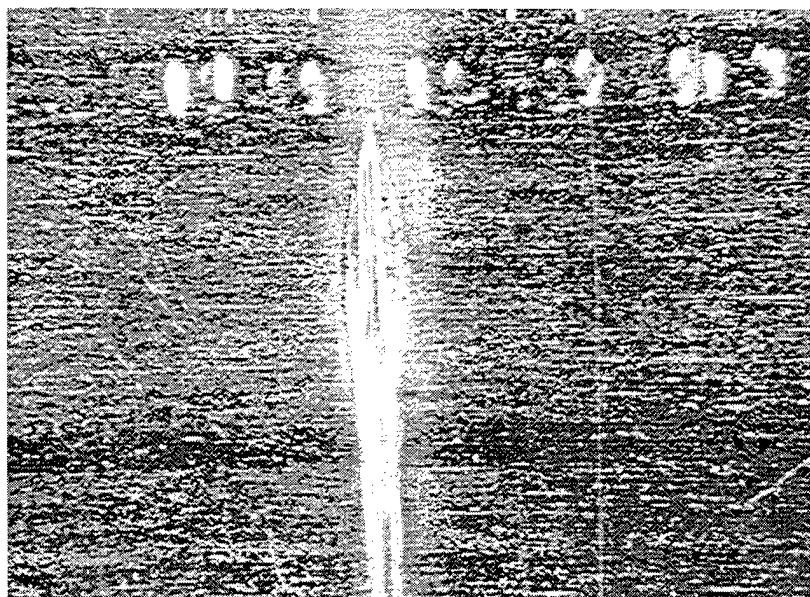
20X

The axial scratches breach the TDC coating and extend into the base M50 material. These scratches were caused by damage during engine assembly when the TDC coated rollers axially slide against the TDC coated race. The circumferential ring of dents was probably caused by raised material on the rollers (transferred from race). Localized TDC peeling was considered secondary damage due to continued operational forces at the edges of the dents. **Figure 135** is a photograph of a typical axial scratch and the adjacent dents.

**Figure 135.** Photo of F110-GE-100 ESN 509-716/5 No. 1R Bearing Inner Race Scratch/Dents. *TDC coating roller bearings demonstrated reduced assembly damage resistance.*

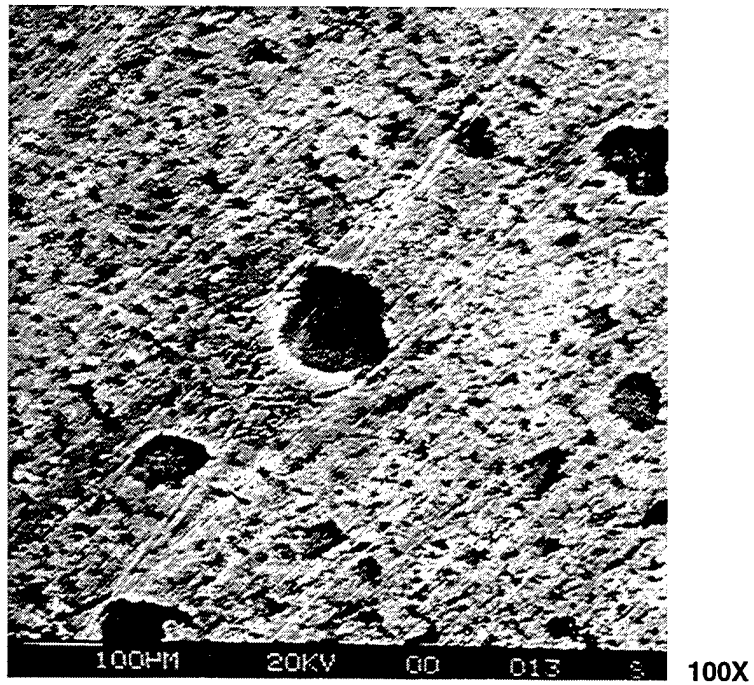
The posttest condition of the No. 2B bearing was considered marginal. Although the condition of the bearing was within inspection limits, there was evidence of undesirable skid damage on the inner race. A circumferential ring of partially peeled TDC areas was present in the location where skidding is likely to occur. **Figures 137, 138 and 139** are SEM photographs of these areas. **Figure 139** highlights a typical area adjacent to a location of partially peeled TDC. Secondary polishing and micro-peeling of the TDC has occurred in these areas.

**Figure 138. SEM Secondary Photo of F110-GE-100 ESN 509-716/5 No. 2B Bearing Inner Race.**
